Resistance to Hard Body Impact Test Report

BS EN 356:2000

The Art Laminated Glass

Our Ref.: J19-127-R01-191023

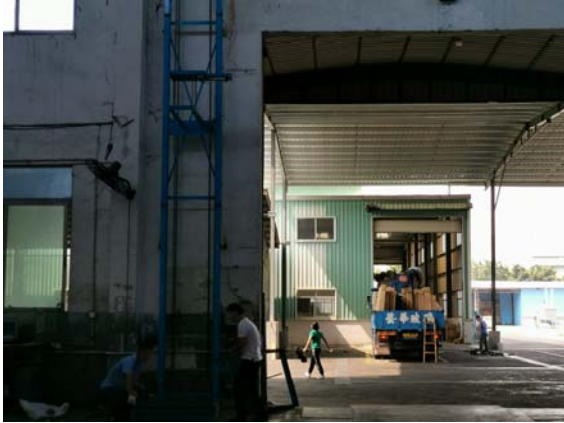
Photo 1
The impactor holding equipment.

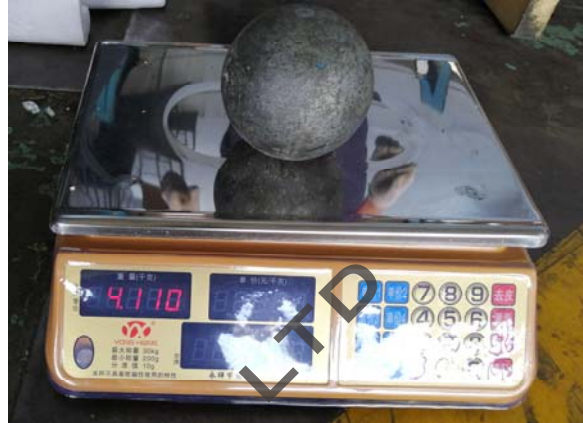
Photo 2
The weight of the impactor was checked.

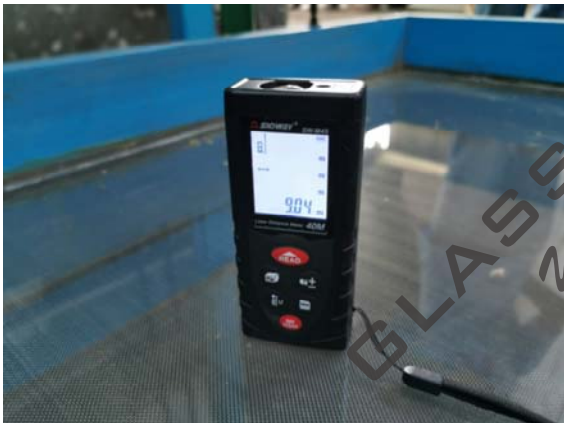
Photo 3
The impact height was checked.

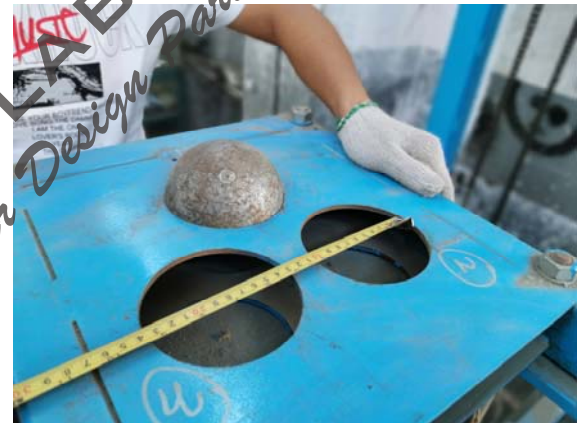
Photo 4
The impact positions form the pattern of an equilateral triangle parallel length of 130mm

For categories P1A, P2A, P3A and P4A, the impactor shall be dropped on to each test piece three times from the same height, in such a way the impact positions form a pattern of an equilateral triangle with a side length of (130 ± 20) mm around the geometric centre of the test piece, with one side of the triangle parallel to a short side of the specimen. The impact position opposite to this side of the triangle shall be hit first.

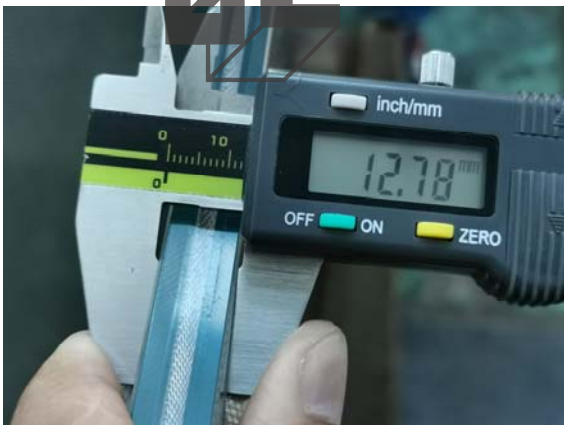
Photo 5
The thickness of the sample was checked.

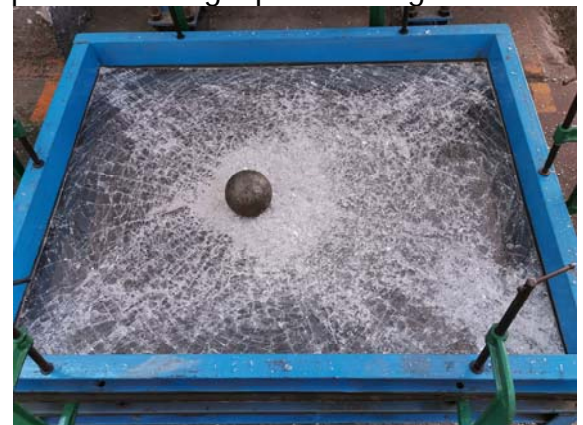
Photo 6
The impactor did not penetrate the specimen after 3x3x9m impacts.

Remark	No opening, no penetration of the ball was observed after all 3x3x9m impacts. Satisfactory.								
Category of resistance	EN356 P5A
